**Flood Control Project Maintenance  
Levee Inspections**  
**LMA District Cover Sheet**  
**Spring 2011 Levee Inspection Results**

**Reclamation District No. 2075 McMullin**

**Levee Inspection Report By Mile - Spring 2011**

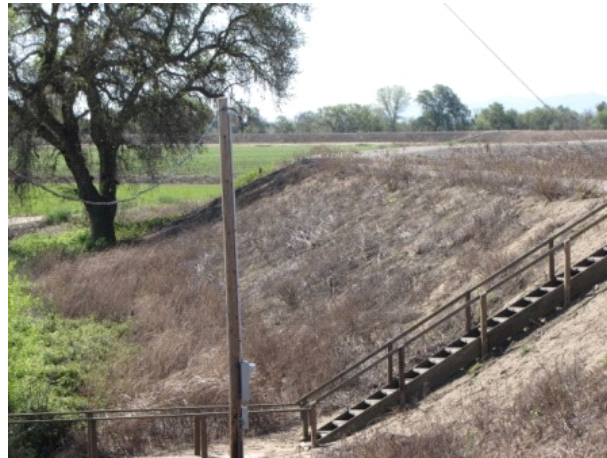
| Levee Mile Report Line | 1 |

| Waterway | | | | | | Bank | Unit Miles | Inspection Start/End | | Inspector |
|---|---|---|---|---|---|---|---|---|---|---|
| 1 | 0.00 | 0.00 | Earthen Levee | Vegetation | LS | A | Control annual grass and weeds on the levee slopes and easements. | ° | ° | 13<br>Y |

This picture shows the landside where District has sprayed the weeds along the levee slopes. Photo was taken 4-6-2011.

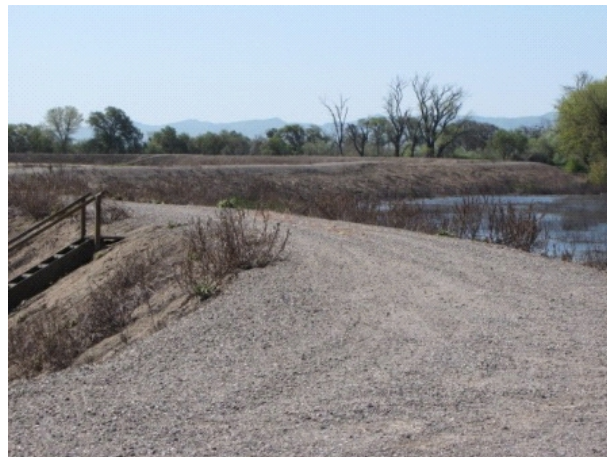
| Levee Mile Report Line | 2 |

| Waterway | | | | | | Bank | Unit Miles | Inspection Start/End | | Inspector |
|---|---|---|---|---|---|---|---|---|---|---|
| 2 | 0.00 | 0.00 | Earthen Levee | Vegetation | WS | A | Control annual grass and weeds on the levee slopes and easements. | ° | ° | 17<br>Y |

Standing downstream from gate at levee mile 0.00 looking downstream along waterside levee slope. Weeds have been sprayed. Photo taken 4-6-2011.

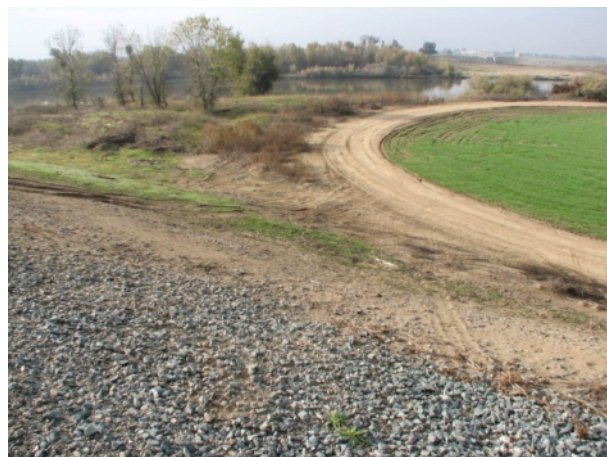
| Levee Mile Report Line | 11 |

| Waterway | | | | | | Bank | Unit Miles | Inspection Start/End | | Inspector |
|---|---|---|---|---|---|---|---|---|---|---|
| 11 | 2.73 | 2.73 | Earthen Levee | Crown Surface / Depressions / Rutting | WS | M | Inspector Comments: This item was identified with an Unacceptable rating in the USACE PI report (MCMU_2009_a_0096). Reinspect on 12/2/10 revealed that repairs were made as indicated in the 11/8/10 letter from KSN, however new depressions present. | 37.725810 °<br>-121.294645 ° | 37.725810 °<br>-121.294645 ° | 18<br>Y |

Photo taken from crown looking down waterside slope during 12/2/2010 reinspection. Repairs were made to depressions on levee slope as indicated in KSN letter. Since then, vehicular traffic has created new ruts in repaired area approximately 1 to 6 inches in depth.

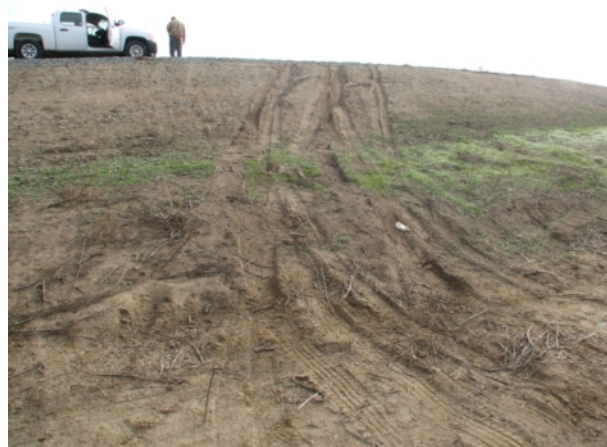
| Levee Mile Report Line | 11 |

Photo taken during 12/2/10 reinspection from the waterside. Depressions from vehicle traffic made in previously repaired area.

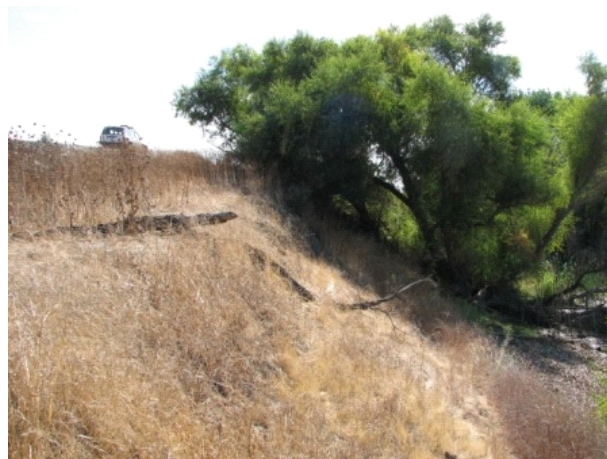
| Levee Mile Report Line | 12 |

| Waterway | | | | | | Bank | Unit Miles | Inspection Start/End | | Inspector |
|---|---|---|---|---|---|---|---|---|---|---|
| 12 | 5.34 | 5.35 | Supplemental | DWR Erosion Survey | WS | U | Inspector Comments: 10/05/2010: No significant changes observed on site. Levee slope has minimal vegetation and lacks rip rap protection. Sandy material found on the lower and middle slope is an undesirable material to have on a levee.<br>08/05/2010: Recommended for annual assessment and monitoring during flood events, per CLRO.<br>[2010 SiteID: RD2075U01RM64.34] | 37.727933 °<br>-121.274491 ° | 37.727933 °<br>-121.274491 ° | 2<br>Y |

Looking upstream of site towards the levee crown.

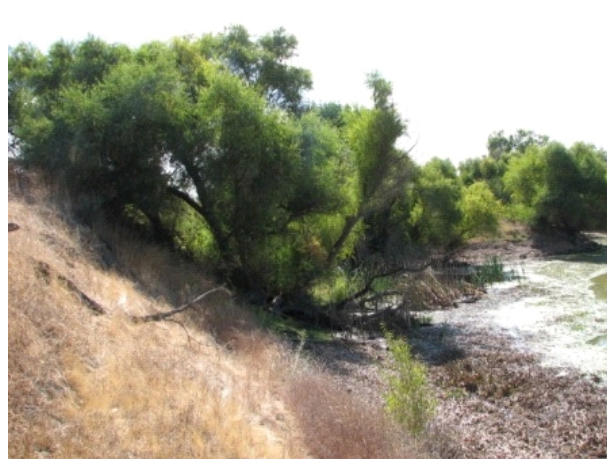
| Levee Mile Report Line | 12 |

Looking upstream of site at the leaning tree.

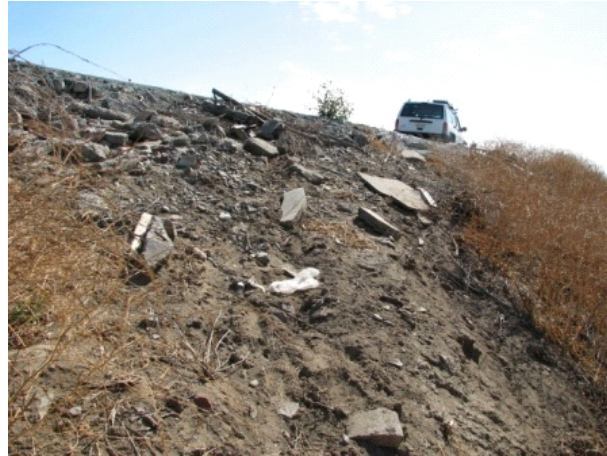
| Levee Mile Report Line | 12 |

Looking upstream of site towards the levee crown.

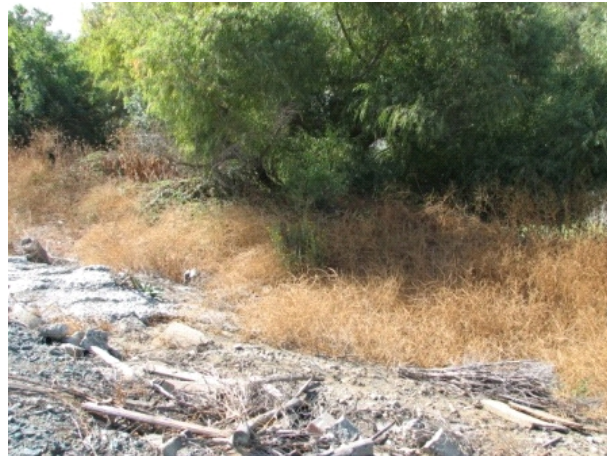
| Levee Mile Report Line | 12 |

View of the affected tree from the levee crown.
